STUDY OF CAVITATION DAMAGE
TO HIGH-PURITY METALS AND A
NICKEL-BASE SUPERALLOY IN WATER

by Stanley G. Young
Lewis Research Center
Cleveland, Ohio 44135

NATIONAL AERONAUTICS AND SPACE ADMINISTRATION • WASHINGTON, D. C. • SEPTEMBER 1970

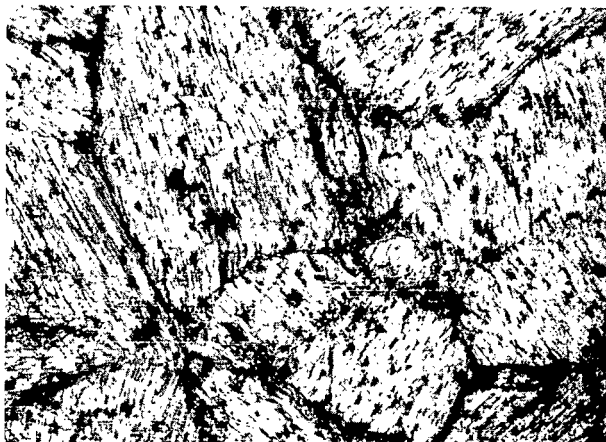
(a) Zinc.

Figure 13. - Photomicrographs of damaged surfaces of specimens exposed to cavitation for various times at 75° F (24° C). (Tested specimens were repolished after 0-min photographs were made.)

Effect of cavitation damage on metal structure. - Photomicrographs of the damaged surface of the unalloyed metals during early stages of cavitation damage are shown in figure 13. Each material was etched after polishing to obtain the micrograph of the untested material in the upper left of each figure. It was repolished before commencing the cavitation exposure.

In the early stages of damage, zinc, which is hexagonal close packed (hcp), showed parallel striations in one direction in each grain (fig. 13(a)). These may be traces of the basal (0001) plane revealed by mechanical etching. Similar striations were observed

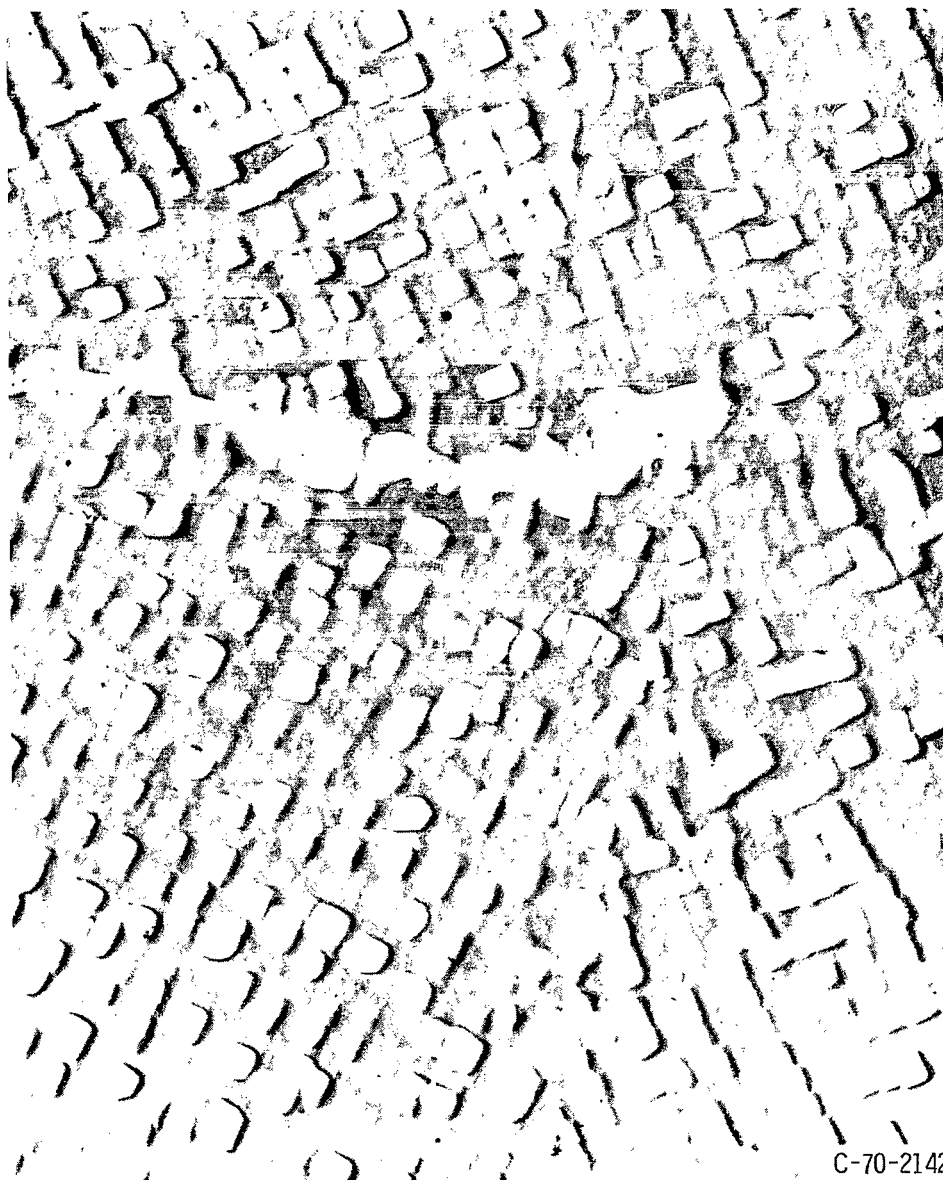
Figure 14. - Electron microscope replica of surface of Udimet 700 subjected to cavitation in water at 75° F (24° C) for 120 minutes. X17 500. (Reduced 30 percent in printing.)

Cavitation appears to be effective in revealing microstructural features of a complex alloy such as Udimet 700. Figure 14 is a replica electron micrograph of such a microstructure showing features typical of a gamma prime strengthened superalloy. It was mechanically etched by 120 minutes exposure to cavitation.
